## Monthly incident insights

### WorkSafe Mines Safety

July 2026 edition

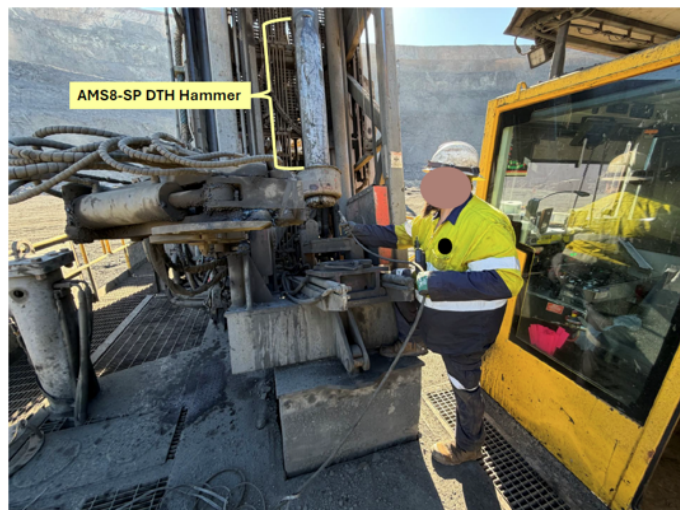
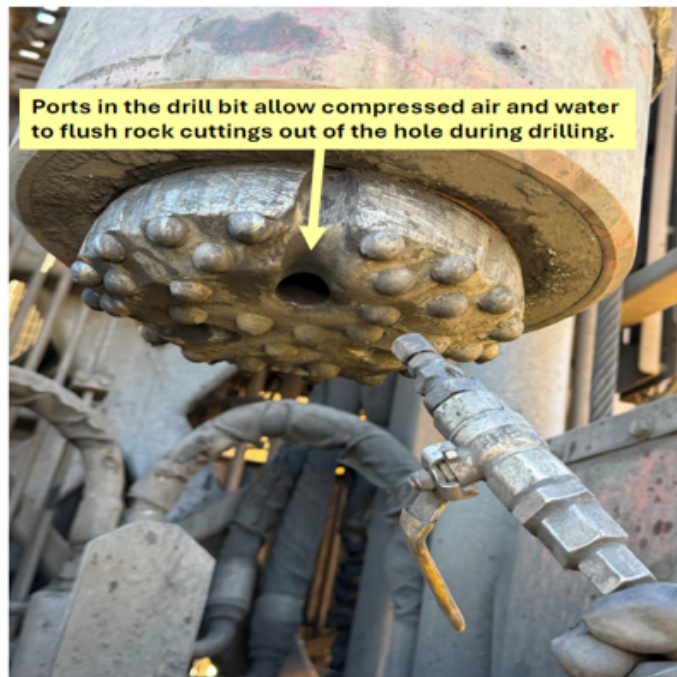
### Stored energy release injures drill operator

A worker sustained a hand injury after stored energy released from a drill string during blockage-clearing activities on a blasthole drill rig. The operator identified elevated pressure readings that indicated a blockage in the drill bit and began dismantling the down-the-hole (DTH) hammer assembly to relieve pressure.

The operator separated the upper section of the DTH hammer from the drill rod string while the drill mast remained angled. Although the operator released pressure from the upper hammer section, pressurised air remained trapped within the drill string and drill bit. The operator then reconnected the assembly and directed a washdown hose into the drill bit ports to clear the blockage. When the obstruction cleared, a high-velocity discharge of air, water, oil and rock fragments expelled from the drill bit ports and struck the worker's hand.

The incident shows how residual stored energy can remain within drilling equipment even after workers complete partial depressurisation. Workers performing fault-finding and maintenance tasks can enter the line of fire when pressure sources remain trapped and work teams do not fully isolate or release stored energy before commencing work.

- **Follow correct depressurisation procedures:** Release all stored energy before disconnecting or dismantling drill string components.
- **Position equipment appropriately:** Set the drill mast to allow safe depressurisation of the drill bit and hammer assembly.
- **Control residual pressure:** Treat drill strings, DTH hammers and drill bits as potentially pressurised until verification confirms otherwise.
- **Remove workers from the line of fire:** Maintain exclusion zones around potential discharge points during pressure-release tasks.
- **Verify work methods:** Apply manufacturer instructions and site procedures during maintenance and fault-finding activities.
- **Supervise high-risk work:** Confirm workers have the training and competency to manage stored-energy hazards.

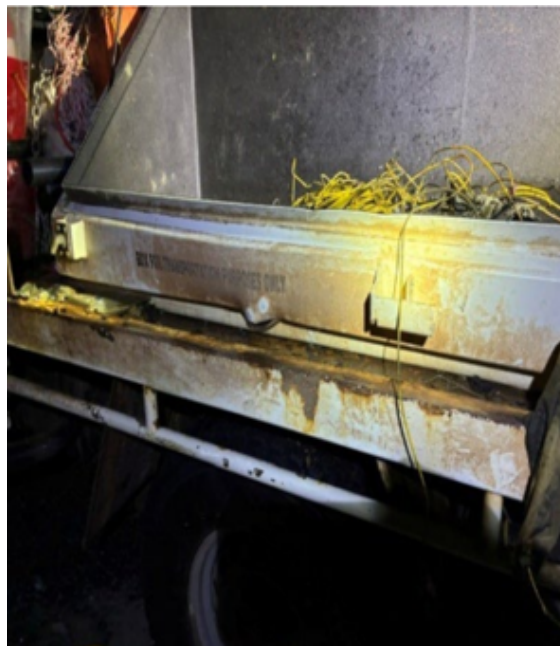
### Detonators initiate in explosives vehicle

A worker encountered an explosives hazard after detonators unintentionally initiated inside an explosives light vehicle during charging activities underground. The event occurred after the worker placed a battery-powered cable tensioning device into

a detonator storage compartment that already contained detonators.

After completing cable tensioning work in an underground heading, the worker returned the device to the vehicle and stored it with the detonators. The worker then returned to the face to assist with charging operations. A short time later, workers heard popping sounds from the rear of the vehicle. They inspected the compartment, identified initiating detonators and a smouldering fire, moved behind the vehicle, suppressed the fire with a mine water hose and notified supervision.

The incident shows how workers can create ignition hazards when they place incompatible equipment inside detonator storage areas and compromise segregation controls. Workers involved in explosives handling can face catastrophic consequences when ignition sources and detonators occupy the same storage space.

- **Maintain segregation controls:** Keep detonator compartments free from equipment and potential ignition sources.
- **Follow explosives procedures:** Apply storage and handling requirements without deviation.
- **Recognise ignition hazards:** Assess battery-powered and electrical equipment before storing them near explosives.

- **Withdraw to a safe location:** Respond immediately to abnormal sounds, heat, smoke or fire.
- **Position personnel outside danger areas:** Move clear of explosives storage areas as soon as workers detect a hazard.
- **Verify competency:** Confirm workers have the training and supervision required for explosives handling activities.
