## Monthly incident insights

### WorkSafe Mines Safety

July 2025 edition

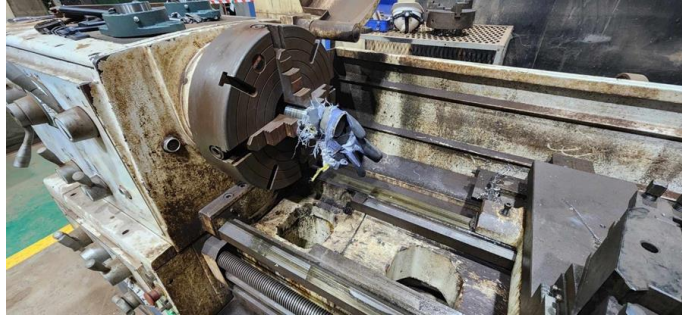
### Lathe entanglement

A worker sustained serious injuries to their forearm and wrist after becoming entangled in the rotating chuck of a lathe. The operator was wearing gloves, which contributed to the entanglement.

While these safety devices are critical, it's important to note that de-energising a large lathe doesn't immediately halt its rotation. Due to the lathe's high rotational inertia, it can continue to spin for several minutes unless an effective braking system is in place.

- **Identify hazards**—Never wear jewellery or loose clothing, including gloves, when operating lathes or other rotating machinery.
- **Use controls**—Ensure rotating equipment is fitted with effective braking systems to stop moving parts quickly in an emergency.
- **Assess risks**—Conduct task-specific risk assessments and ensure that workers know the

- **Test tools**—Regularly inspect and try out emergency stops and braking systems as part of maintenance programs.

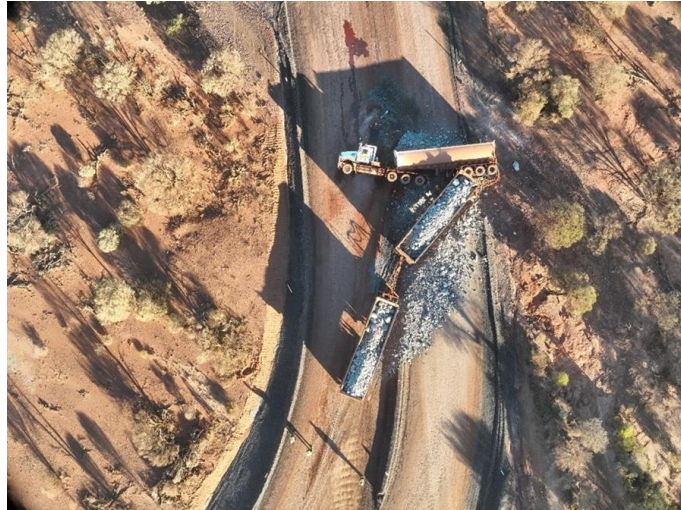
### Road train rollover

A road train rollover occurred on the haul road access route to a gold mine, resulting in serious injuries to the operator.

The incident took place as the operator was navigating a sweeping bend while hauling ore. The cab and the first trailer overturned, while the remaining two trailers remained upright.

- **Identify hazards**—Confirm vehicle operators know hazard identification and response procedures, especially for haul roads.
- **Inspect vehicles**—Foster robust vehicle inspection and maintenance regimes, including thorough pre-start checks.
