Monthly incident insights WorkSafe Mines Safety

April 2026 edition

Issued 20 May 2026

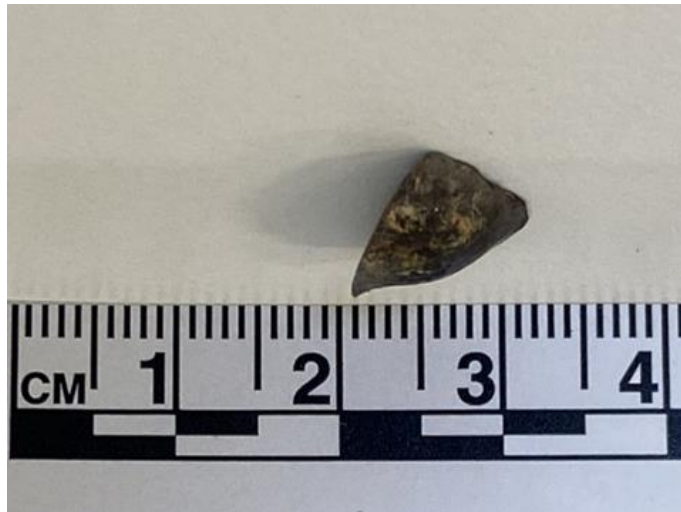
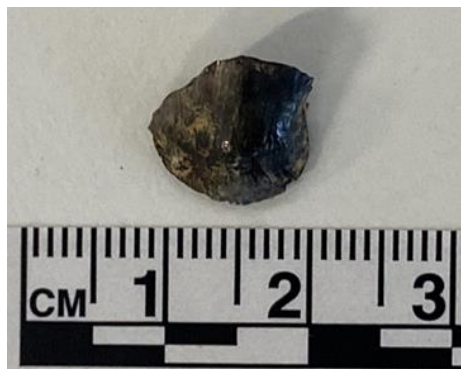
Striking tasks eject metal shards and injure workers

Maintenance teams continue to face a serious and preventable hazard: metal fragments ejected during striking tasks. Incidents have occurred during the removal and installation of bucket teeth—known as ground-engaging tools (GET)—as well as hinge pins and locking pins. When workers strike these components, metal shards can break free and travel at high speed.

These incidents have injured field service and maintenance fitters, with metal fragments embedding in legs, groins, arms and necks, often requiring medical treatment. These events highlight the serious consequences of uncontrolled line-of-fire exposures and demonstrate how quickly routine tasks can escalate into high-risk situations.

Investigations show that maintenance teams often underestimate this hazard. In several cases, workers used incorrect or poorly maintained tools, bypassed original equipment manufacturer (OEM) instructions or site procedures or worked without adequate supervision and task planning.

- **Eliminate line-of-fire exposures:** Remove non-essential personnel from work areas and position workers outside impact zones.
- **Plan tasks thoroughly:** Conduct risk assessments and review work practices to reduce the probabilities and consequences of projectile hazards.
- **Use correct tools:** Select well-maintained and properly dressed tools suitable for tasks, including soft-face hammers where appropriate.
- **Ensure competency and supervision:** Train and assess workers and actively supervise them during high-risk maintenance tasks.
- **Apply engineering controls:** Use mechanical aids to reduce manual striking and deploy ballistic shielding where workers cannot eliminate projectile risks.
- **Wear appropriate personal protective equipment:** Follow OEM instructions and site procedures, including the use of face shields and protective clothing.

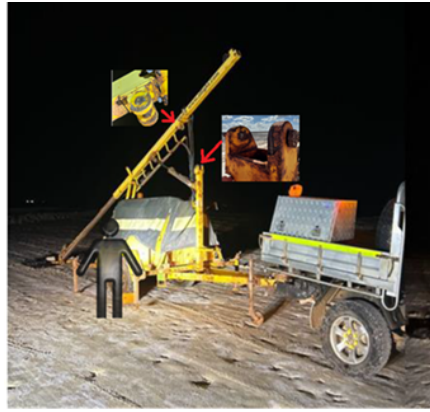
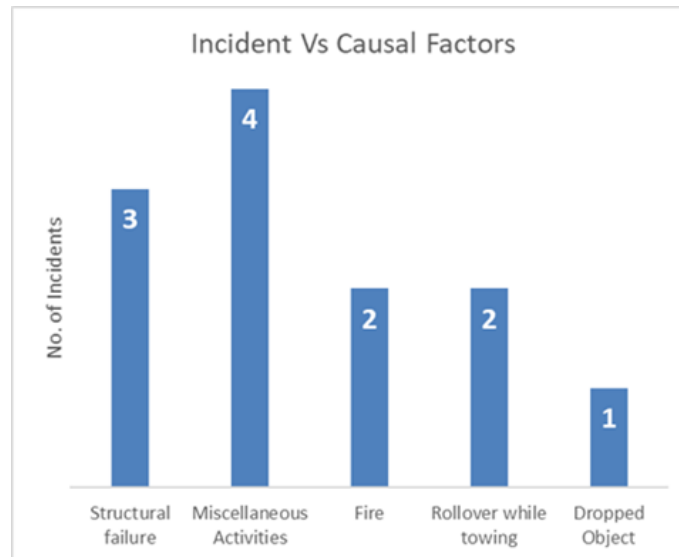
Tower incidents highlight structural and operational hazards

A review of lighting tower incidents reported across Western Australia over a 13-month period has identified recurring hazards, common failure modes and systemic gaps in asset management. The incidents included structural failures, fires, dropped objects and injuries sustained during routine handling and towing activities, many of which had the potential to cause serious or fatal outcomes.

Structural failures were the leading cause of high-potential incidents, with multiple cases involving failed pivot components, collapsing masts and corrosion-driven instability. Electrical faults ignited fires in several towers, while a detached solar panel created a significant dropped-object hazard. Workers also sustained hand and finger injuries during set-up, pack-down and towing tasks.

- **Implement routine inspections:** Establish and document regular structural inspections to identify corrosion, wear and component fatigue.
- **Remove defective equipment from service:** Repair or replace damaged, worn or compromised components promptly.
- **Verify structural integrity before use:** Conduct thorough pre-start inspections prior to operations, relocations and pack downs.
- **Apply safe towing practices:** Follow documented procedures to prevent instability, rollovers and trailer detachments.
- **Assess task-specific risks:** Identify hazards during set-up, pack-down and handling activities, with a focus on pinch points and manual tasks.
- **Eliminate line-of-fire hazards:** Keep workers clear of collapse zones, suspended components and dropped-object risks.
- **Maintain electrical systems:** Inspect and test wiring and components regularly to detect faults

and reduce fire risks.

- **Standardise procedures:** Develop and implement consistent processes for operating, relocating and maintaining lighting towers.
