## Monthly incident insights

### WorkSafe Mines Safety

October 2025 edition

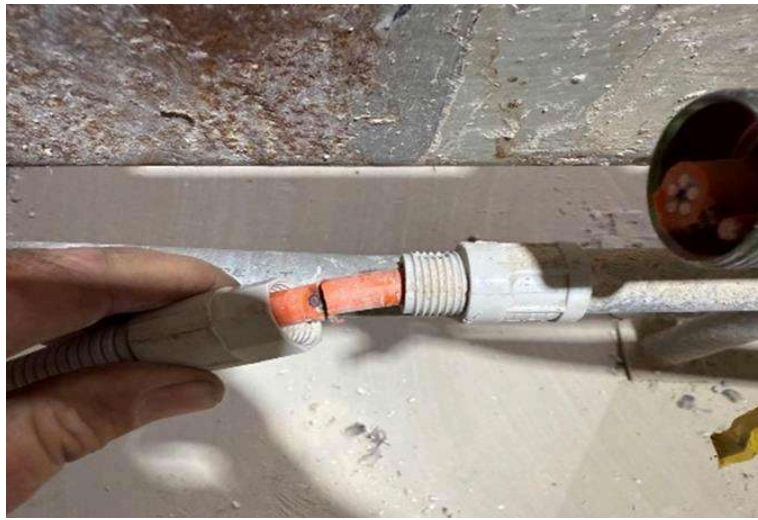
Workers using a grinder to remove a redundant conveyor inadvertently cut into a live electrical cable after they incorrectly assumed that all nearby cables had been de-energised.

The electrical supervisor had confirmed to the workers that the conveyor motor was redundant and its electrical cables were safe to cut. However, the workers mistakenly thought that other nearby cables were also redundant and de-energised.

The cut electrical cable was not part of the redundant conveyor and was still live, posing a serious risk of electric shock, arc flash or electrocution. The incident did not result in any injuries, but it highlighted critical failures in electrical isolation, verification and supervision.

- A qualified person must test and verify that all electrical components are de-energised before work begins on equipment.
- Electrical supervisors must consider the complexities of tasks and the capabilities of workers when they are assigning jobs involving electrical cables or exposed electrical equipment.
- Sites should involve electrical supervisors in all high-risk work assessments, and all job hazard/safety analysis processes should include electrical verification and isolation steps.
- In Western Australia, the Electricity (Licensing) Regulations 1991, the Work Health and Safety (Mines) Regulations 2022 and several Australian Standards, including AS/NZS 3000:2018 (Electrical installations, known as the Wiring Rules) and AS/NZS 4836:2023 (Safe working on or near low-voltage electrical installations and equipment), govern electrical isolation requirements.

Workers must treat all electrical work as live work until proven otherwise. Assumptions can lead to catastrophic work health and safety consequences.

Isolation, testing and supervision are essential controls to prevent serious injuries or deaths.

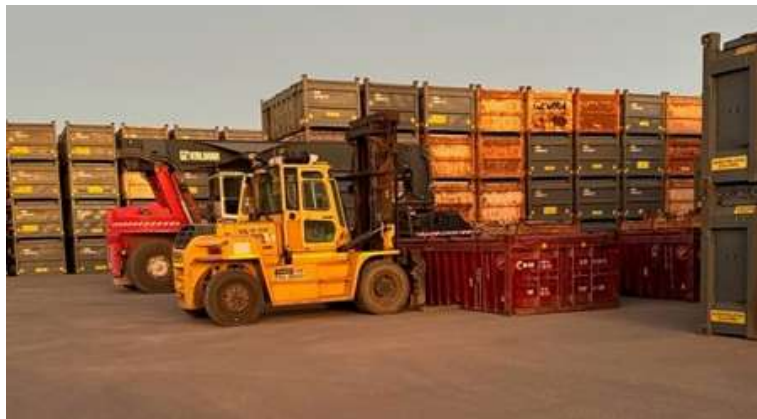
A worker was momentarily trapped between moving and stationary sea containers after a container shifted unexpectedly during a non-routine forklift operation to facilitate a quarantine inspection.

A sea container moved after the forklift operator lifted its lid. The worker managed to withdraw without injury, although they went to the hospital as a precautionary measure. Site management preserved the scene before a WorkSafe inspector attended and reminded everyone of the exclusion zone and pedestrian-plant separation requirements.

Exclusion zones and pedestrian–plant separation were not maintained because the worker was too close to the operating mobile plant, which created a foreseeable crushing hazard and potential for a serious incident. The non-routine task lacked specific risk controls.

- Sites must maintain pedestrian–plant separation at all times.
- Traffic management and exclusion zones must reflect real site conditions, and mine operators must enforce them consistently.
- Non-routine tasks require dedicated planning and supervision.

Employees can sustain serious injuries when employers expose them to mobile equipment without effective controls. Sites must plan, verify and enforce critical controls, exclusion zones and safe operating procedures for all tasks, especially non-routine work.
