## Monthly incident insights

### WorkSafe Mines Safety

May 2026 edition

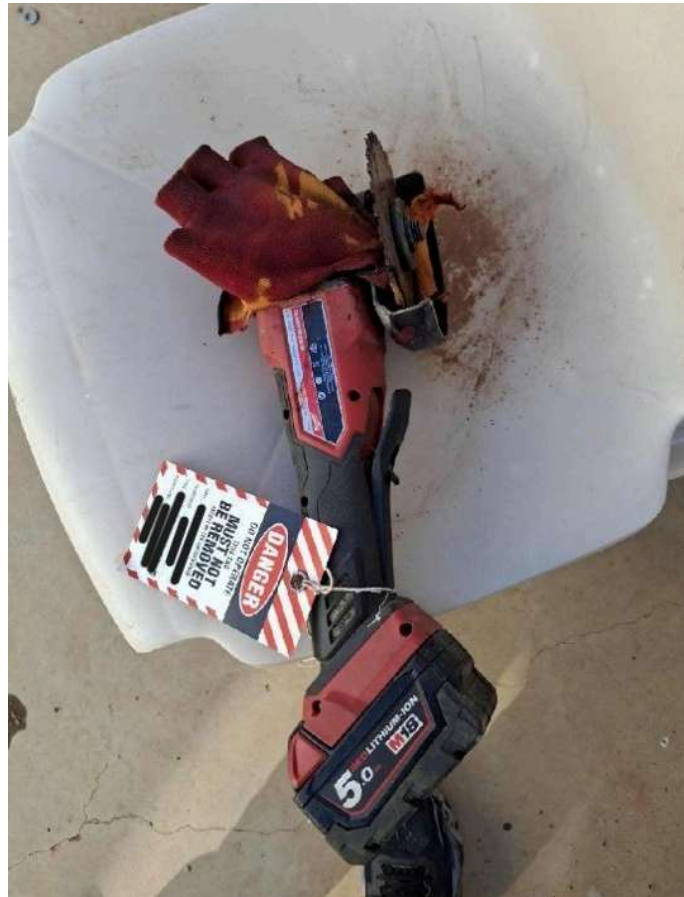
A worker sustained a serious laceration to the left hand and thumb when a battery-powered cutting tool kicked back during vegetation clearing around an air-conditioning unit. The worker held a branch with one hand and operated the tool with the other.

As the blade engaged the branch, it bound and kicked back into the worker's hand. The blade cut through the glove and into the hand, while the glove partially stalled the tool and reduced injury severity. The worker used one-handed operation and placed the hand directly in the cutting path.

The incident shows how incorrect tool selection and poor positioning expose workers to kickback and line-of-fire hazards. It demonstrates how quickly routine tasks escalate when workers do not maintain control of cutting tools or keep hands clear of moving blades.

*The battery-powered cutting tool*

- **Select suitable tools:** Use equipment designed for vegetation cutting instead of powered cutting blades where practicable.

- **Maintain control:** Operate tools with both hands and ensure all handles remain fitted and functional.
- **Assess tasks:** Identify hazards, exposure points and safer methods before starting work.
- **Position safely:** Keep hands and body parts outside cutting paths at all times.
- **Plan work:** Schedule vegetation maintenance to reduce the need for reactive clearing.
- **Apply higher-order controls:** Do not rely on personal protective equipment as the primary means of protection.
